RESHARPENING IMPELLER BLADE LEADING EDGES

OUTBOARD JETS
5/6/98

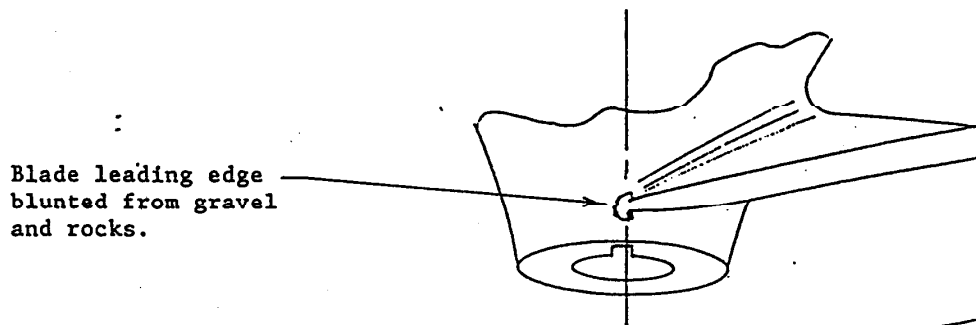
If the impeller blade leading edges are badly blunted and not cutting the water cleanly, it can cause excess motor RPM (slippage) during acceleration and cavitation burns on the impeller blades.

Blade leading edge blunted from gravel and rocks.

Step 1 File along slope of upper side of blade.

Step 2 File along underside of blade until leading edge approx. $\frac{1}{32}$ " thick.

Step 3 Blend underside of blade in gentle curve.

CAUTION DO NOT bevel leading edge of blade as shown.
